Heavy vehicles tire blowout and explosion: Technical fact sheet intended for personnel assigned to heavy vehicle repair and maintenance

HEAVY VEHICLES TIRE BLOWOUT AND EXPLOSION

March 2009

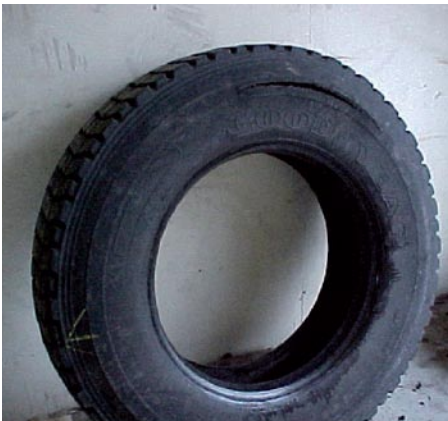
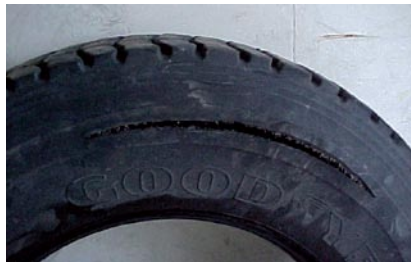
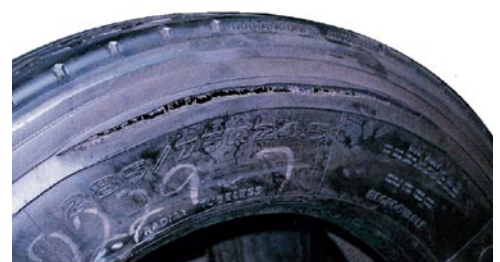
A design defect, an overloading or an impact can cause a weakness, a cracking or a rupture of the tire carcass. The result can lead to significant air loss, the projection of tire fragments, and a sudden drop in pressure at this location, sometimes accompanied by a mark resembling an unstitched or unzipped fabric.

- deterioration of the envelope exposing the plys or the belts of the tire to contamination by air or humidity
- mechanical impact that damaged the tire's structure
- driving with underpressurized tire below 80% of the recommended pressure
- driving with overpressurized tires
- overloading
- loss of mechanical properties due to heat, pyrolysis or thermo-oxidation
- significant carcass wear
- design defect in the weave of the tire cord.

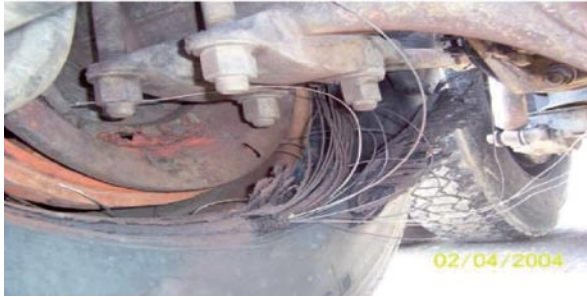
Photo no. 1: Example of a tire that burst following brake overheating (locked brakes).

In the event of blowout or explosion, the violent blast or the projection of fragments can cause serious and even fatal injuries to anyone who is nearby. Photo no. 1 shows a burst tire that resulted in the worker's death. Photo no. 2 shows a tire that burst following the initiation of an electric arc produced when a flatbed semitrailer was parked near a high voltage line.

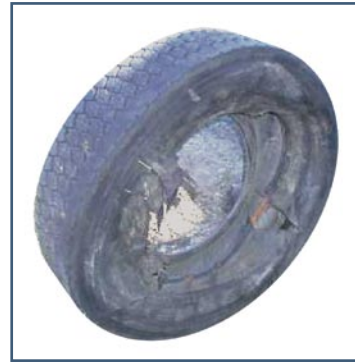
Photo no. 2:
Tire that burst,
semi-trailer hit
by an electric arc
near a high voltage
line.

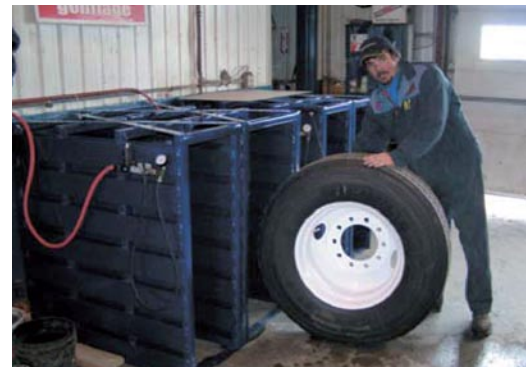
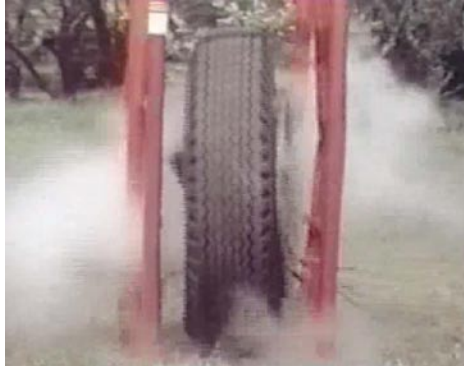
Truck tire blowout in a safety cage.

On the photograph at the left, you can see the trajectory that the debris may take following tire blowout.

On the photographs below, we see that the energy released during blowout deforms the safety cage, as well as moving it and rotating it. It is important that the worker stay outside the trajectory of the debris and far enough away from the cage so as not to be injured by it.

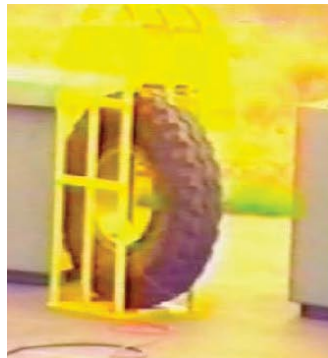
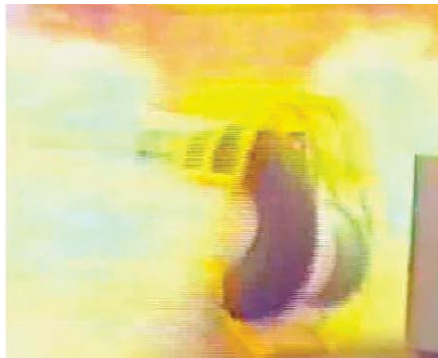
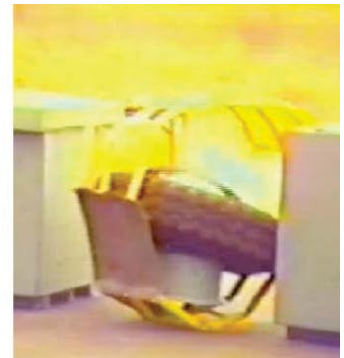
Three sequences of tire blowout with projection of the rim in a safety cage.
